TIRE CASING RETREAD AND REPAIR MANUAL FOR ECDII™ AND DURASEAL TECHNOLOGY®

GOODYEAR
Get there®

This *Tire Casing Retread And Repair Manual For ECDII And DuraSeal Technology* gives an overview of ECDII and DuraSeal Technology. Most importantly, it covers the specific retread and repair procedures and standards for casings with ECDII and DuraSeal Technology.

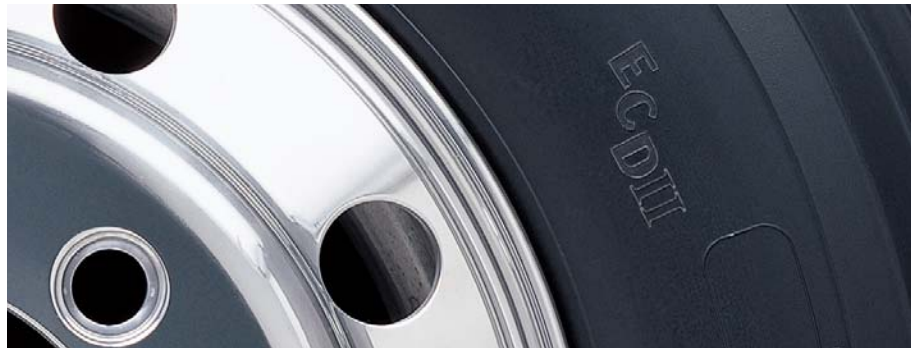
An ECDII casing contains a four (4) steel belt package. There is no polyamide fabric breaker. As a result, the ECDII casing should be buffed the same as any standard four (4) steel belt casing.

WHEN BUFFING AN ECDII CASING, NO ADJUSTMENT OF THE AUTOMATIC BELT DETECTION SYSTEM IS REQUIRED TO OBTAIN THE PROPER GAUGE ABOVE THE STEEL TOP BELT.

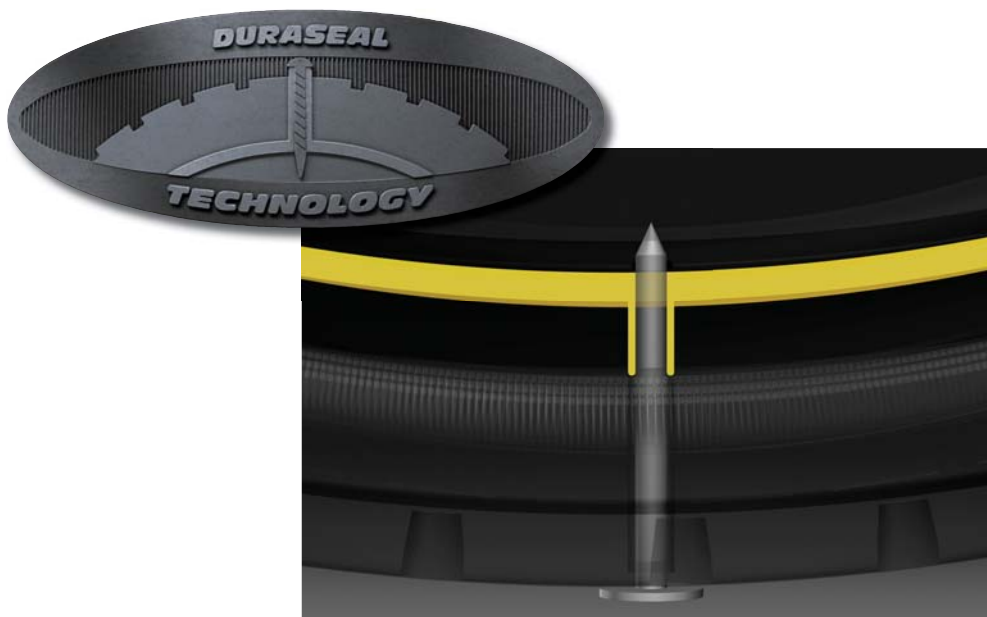
DuraSeal Technology is the world's first built-in tire sealant for commercial truck tires. Built into the crown of the tire, DuraSeal Technology is a yellow, gel-like rubber compound that can seal a 1/4-inch tread puncture while the tire is in service to avoid vehicle downtime. It also helps minimize the chance of chamber fires and the likeliness of liner surface contamination because there are no liquid sealants applied to the inside of the casing after mounting.

Seals up to 1/4-inch punctures only in the repairable area of the tread.
Does not seal sidewall punctures.

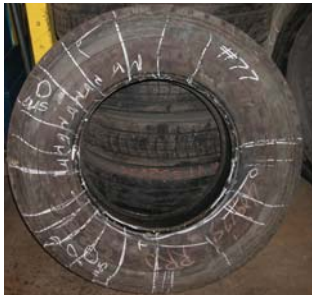
Figure 2

The DuraSeal Technology compound, while not liquid, is fluid enough to move or migrate in service. When filling a puncture, the compound may migrate out of the liner and, in some cases, may even be visible on the outside of the tire. There may be areas of the liner where the compound has moved and will create a depression. Other areas may have an accumulation of sealant material and exhibit lumps or thick spots (*Figure 2*). This is considered normal. The compound will spread out evenly when the tire is in service.

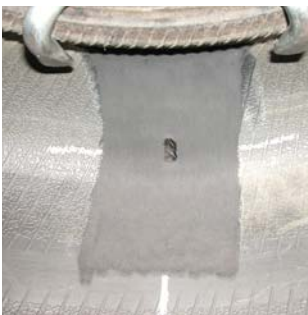
Figure 7

Tire section repairs where the injury is in the sidewall should not result in any additional difficulty (*Figures 7 and 8*). Care must be taken when buffing the liner in the sealant area since it may not be firmly attached to the casing. DuraSeal Technology compound does not extend beyond the belt edge/shoulder area, so it will not affect preparation on the sidewall section to be repaired. Tread area section repairs will require extra attention. A damaged liner may have to be removed as described in the puncture repair procedures.

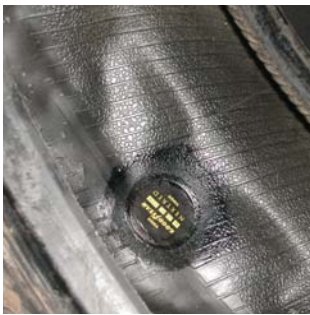
Figure 9

When the retreaded casings are removed from the curing chamber, the liner may appear separated. Normally, the liner should be tight to the casing from the beads to the upper sidewall/shoulder. However, in the tread crown area where DuraSeal Technology is present, the liner may swell or bubble and appear separated (*Figure 9*). This is normal for casings with DuraSeal Technology. The air will dissipate when the tire cools.
